Early Screw Migration into the Bladder and Spontaneous Expulsion: A Rare Complication after Internal Fixation of the Pubic Symphysis

Labronici PJ^{1,2*}, Pereira LF², Cabral GG², Hoffmann R², da Silva LHP² and Giordano V^{3,4,5}

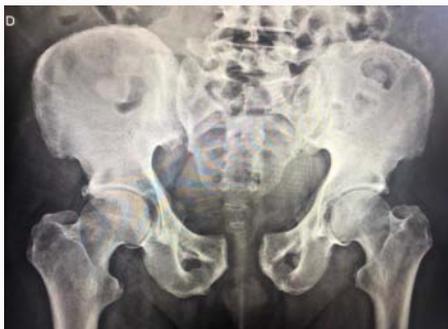
Male patient, 64 years old, victim of a fall from a roof, approximately three and a half meters high on November 25th, 2021. Upon admission to the orthopedic emergency room, after physical examination and imaging tests, the opening of the pubic symphysis chapter II was diagnosed (Figure 1).

Figure 1: Antero-posterior X-ray of the pelvis with the pubic symphysis lesion.

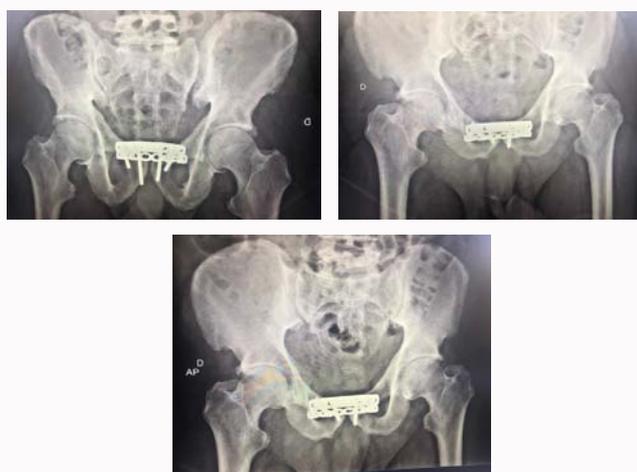
Both the patient and the fracture remained stable throughout the treatment, and it was decided not to temporarily fix the pelvis with an external fixator. After carrying out all the preoperative preparation, the definitive orthopedic surgical procedure was performed seven days after the trauma. A pelvic approach was used through the Pfannenstiel access, with associated detachment to protect the urinary bladder. The orthopedic surgical technique used was the placement of two orthogonal plates, one superior and one anterior. Top plate was large fragment DCP with 4 mm × 4.5 mm screws. The anterior reconstruction plate was made of small fragments with 4 mm × 3.5 mm screws. Satisfactory radiographic control was performed at all stages (Figure 2).

Figure 2: Images of symphysis fixation with two plates in antero-posterior, inlet and outlet view.
