Inadvertent Malposition of Temporary Pacing Lead in the Left Ventricle during Emergent Percutaneous Coronary Intervention: Passed Through the Patent Foramen Ovale

Bong Gun Song* and Hyun Chul Jo

Department of Medicine, Seongnam Citizens Medical Center, JO HYUN CHUL Heart Clinic and Internal Medicine, Republic of Korea

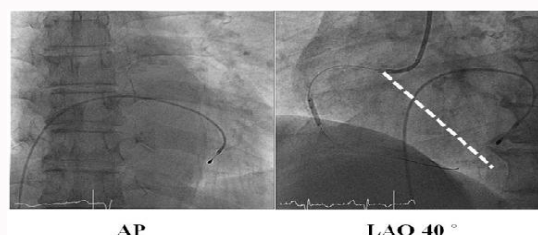
Figure 1: Fluoroscopic images during the PCI. The white oblique dotted line indicates the direction of interventricular septum.
AP: Anteroposterior; LAO: left anterior oblique

Emergent coronary angiography was immediately performed and revealed a total occlusion in the middle of Right Coronary Artery (RCA). Before RCA intervention, prophylactic temporary pacemaker was inserted *via* right femoral vein approach for the AV block during the procedure. With the help of fluoroscopic images, a pacing lead was advanced until it reached RA. Then, the pacing catheter was passed smoothly to the ventricle without any resistance (Figure 1). PCI was performed for the RCA, and coronary blood flow recovered completely. The patient was moved to Coronary Care Unit (CCU) immediately after PCI. The patient was stable without any symptom. Surface ECG at CCU showed normal sinus rhythm with coincidental two pacing beats with Right Bundle-Branch Block (RBBB) morphology and early pre cordial transition (Figure 2).

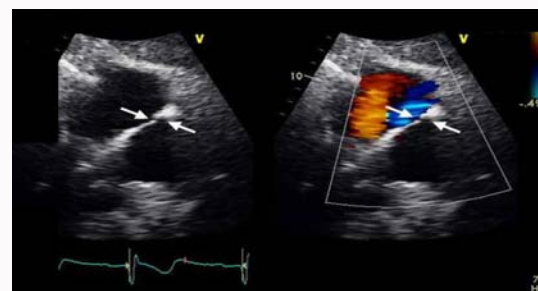
Figure 4: Two-Dimensional transthoracic echocardiography images suggest the evidence of PFO without shunt flow. The white arrows indicate the site of PFO.
PFO: Patent Foramen Ovale

On the two-chamber/four-chamber views, the pacemaker lead tip was located apical inferior septum in LV (Figure 3), passed though the incidental PFO (Figure 4). Finally, the temporary pacemaker lead was removed with the guidance of TTE.
