## Sinus Elevation for Implant Placement Leading to Implant Failure and Natural Tooth Extraction: A Case Report

### Abstract

**Case report:** This case report presents an implant failure, persistent sinusitis and extraction of natural tooth that are caused by odontogenic infection during. A patient was treated with the simultaneous sinus elevation and dental implant placement for rehabilitation of the maxillary molar, which is adjacent to a natural tooth with intact root canal filling. Four months later, maxillary sinusitis was diagnosed reflected by nasal obstruction and foul-smelling discharge. The mobile implant was removed and replaced by a short implant without sinus elevation surgery. However, repeated symptoms of sinusitis was observed, which immediately healed after the extraction of natural tooth. Then the patient received implant insertion in the region of missing tooth, and no further complications were observed.

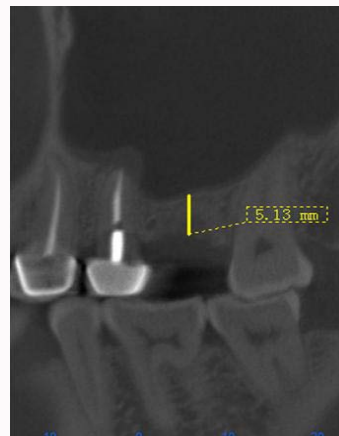
**Figure 1:** CBCT indicates 5.13 mm of the Residual Bone Height (RBH) at the missing first upper left molar before treatment.

A 44-year old woman visited the clinic for reconstruction of the upper left first molar. Cone Beam Computer Tomography (CBCT) examination indicated that the Residual Bone Height (RBH) at the missing tooth region was about 5.13 mm, and no abnormalities of the sinus cavity was observed (Figure 1). The roots of upper left second premolar protrude into sinus cavity. Patients reported that the premolar received endodontic treatment that then received a post-core and porcelain-fused-to-metal crown several years ago.

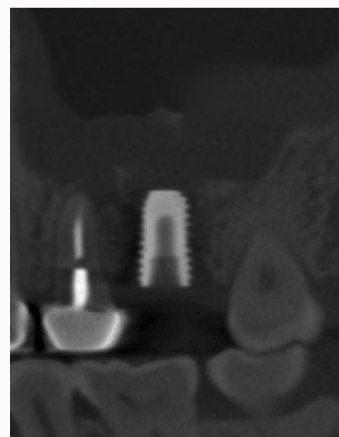
**Figure 2:** Four months after implant placement surgery, CBCT examination showed significantly thickened sinus membrane and periapical radio lucency involving both the apical regions of the second premolar and dental implant.

The minimally-invasive transcresal sinus augmentation was performed using xenogenic graft (Bio-Oss, Geistlich Pharma); the vertical distance from sinus membrane to the alveolar crest was about 12 mm after the sinus elevation. Simultaneously, the implant (Osstem Implant Co., Busan, Korea, with 5 mm in diameter and 10 mm in length) was inserted with a good primary stability. However, four months later, the patient complained pain in the implant region, and nasal symptoms including nasal obstruction and discharge. Implant mobility was evident by intraoral observations. Thickening of sinus mucosa and large periapical radio lucency involving both the apical regions of the second premolar and dental implant were observed on CBCT images (Figure 2). Maxillary sinusitis was diagnosed by otorhinolaryngologist. We removed the mobile implant (Figure 3), performed lavages with sterile saline, and prescribed antibiotics. The symptom of nasal obstruction and discharge relieved along with the healing, with favorable evolution.

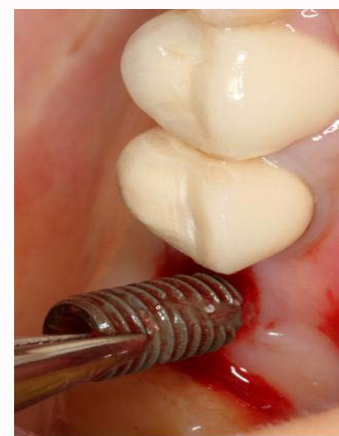
**Figure 3:** Implant removal was performed four months after placement.

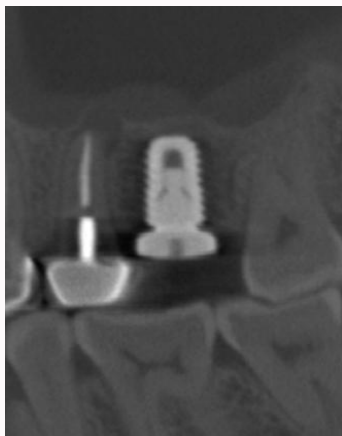
**Figure 4:** A new implant with 8.5 mm in length was inserted into region where the implant was removed without the surgery of sinus elevation.

Six months later, only occasional nasal obstruction was reported by the patient, and no significant abnormalities were observed in the sinus based on CBCT examination. Progress appears to be satisfactory, so re-implantation treatment phase was initiated. We inserted a new implant with 5 mm in diameter and 8.5 mm in length (9 mm height of RBH at implant region was observed by CBCT measurement) without the surgery of sinus elevation (Figure 4). Then the patient was prescribed antibiotics for 3 days.

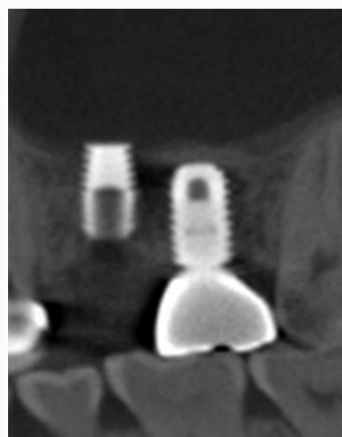
**Figure 5:** The implant was inserted 6 months after the extraction of the second premolar.

The patient was clinically evaluated 1 month and 3 months after tooth extraction, absence of nasal obstruction and discharge was recorded. The post-surgery CBCT at 6 months showed complete resolution of maxillary sinusitis and 1mm thickness of sinus membrane. Then the implant (Bicon, America, 5 mm in diameter, and 8 mm in length) was inserted into the second premolar region (Figure 5). No further complications were observed, and the implant was exposed and restored as planned in 4 months (Figure 6). The patient received a follow-up examination every 3 months, and the
