The Metal vs. Calcium in Complex Atherosclerosis

Abstract

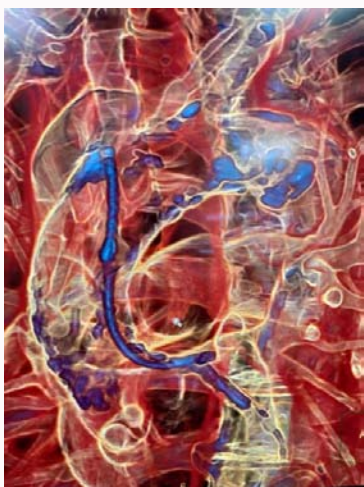
Figure 7: Linear formation extending from LM in the ascending aorta towards brachiocephalic trunk (CT scan).

Two days after the initial procedure on routine echocardiography, a hyperechogenic formation was observed in the aorta. A CT scan revealed a linear formation (possibly metal or calcium) extending from the Left Main (LM) in the ascending aorta towards the brachiocephalic trunk, without any signs of dissection (Figure 7). It was concluded that this could be the larger fragment of an unimplanted stent, and a decision was made to extract it percutaneously.

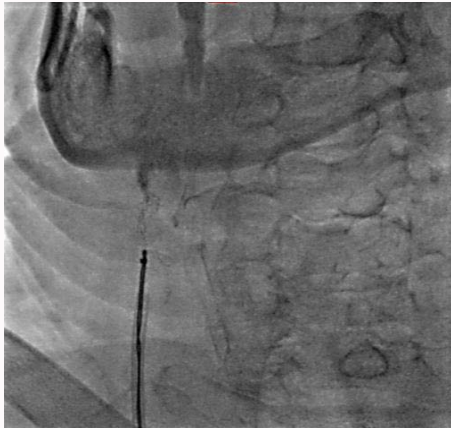
Figure 10: Capture of the distorted stent from LCx in right coronary artery with the snare device.

repeated PCI (Figure 10, 11). The “inverted T” stenting was employed with 3.5 mm × 12 mm stent implanted in Cx, followed by 3.5 mm × 28 mm stent from LM to LAD. POT was done using 4.5 mm × 8 mm NC balloon and after rewiring and angioplasty of Cx ostium with NC 3.0 mm × 12 mm, “kissing” inflation was done with 3.5 mm × 12 mm NC balloons in both arteries. The final result was good, (Figure 12) and patient was discharged three days after the procedure.
