## Distinctions between *Peri* and *Postmortem* Bone Lesions on a Burnt Body in the Aftermath of a Road Accident

### Abstract

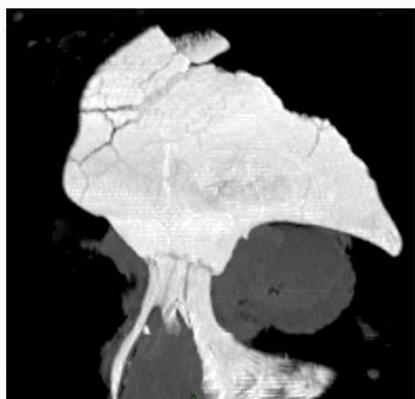
Figure 1: Flaking and cortical fissures.

Facing the skull was found a bursting of the calvaria associate with the existence of fractures and cortical fissures, a predominant flaking at the vault with bare auras of the dipole and a split dipole sign, all related to fractures of thermal origin (Figure 1,2).

spongy area opposite an epiphysis. The CT scan analysis can then be used to visualize the fracture lines within the cancellous bone, parallel to the cortical surfaces, known as the "split dipole sign" in relation to the calvaria (Figure 2). The reticulated fissures are superficial cortical fissures (Figure 1) - in a network with more or less tight and regular meshes - most often on wide areas with little thickness of soft tissue such as the skull, which would indicate regions less exposed to the heat.

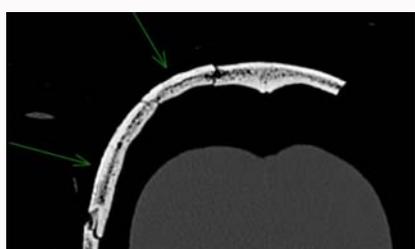
Figure 2: Split dipole sign or fracture of the spongy bone in the dipole.

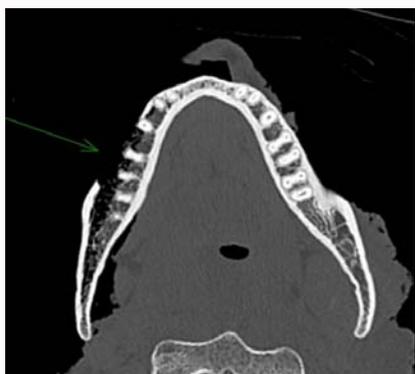
Figure 3: Decortications of the right external face of the mandible body.

A decortications site was also observed vis-à-vis of the external face of the right side of the mandible body, with exposure of the spongy tissue, associated with significant loss of tissue substances affecting the right hemiface (Figure 3).

The case of the victim found incarcerated and charred in her vehicle thus raised several questions: was it a polytraumatized victim unable to escape from the vehicle then secondarily burnt, or a victim neutralized by the fire fumes then secondarily burnt. Symes et al. [2] has described diagnostic bone characteristics specific to thermal injuries. Longitudinal fractures are very common, and follow the architecture of haversian tubes. For some authors, they only occur on dry bone. Helical fractures, as seen in this case, represent a variant of longitudinal fractures (Figure 5). Transverse fractures, also very common, perpendicular to the haversian architecture and therefore parallel to the orientation of the Volkmann tubes. They are due to the perpendicular arrival of heat on the bone and can thus be seen just as much as transverse fractures, particularly on the upper limbs when the pugilist's position is set. For some authors, they are especially visible on greenstick fractures [3]. Oblique fractures have arciform diaphyseal ends associated with beveling between the cortex and the spongy bone; they are also called fractures in "bec-de-flûte". They reflect the evolution of an arciform fracture with detachment of the bone (Figure 5, 7). Decortications or delamination are areas of the cortical bone that are detached under the effect of heat, exposing the dipole of the skull by crumbling of the outer table (Figure 3) or the

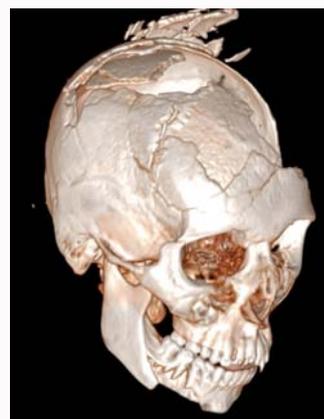
Figure 4: Bursting of the calvaria, dental crowns of the incisors of the upper dental arch and decortications of the right external face of the mandible body.

A fine linear scattered hyper density was found at the surface of the brain related to the desiccation and shrinking phenomena of the encephalon. In addition, a sagging burst of the left eyeball and dental

crowns of the incisors of the upper dental arch were also observed (Figure 4).

The cranial vault can be subject to a "pressure cooker" effect and explode due to the internal pressure of water steam (Figure 4,8) [4]. On the skull, the fissures readily appear facing the temporal or frontal regions, as these are the most exposed. These fissures are mainly bilateral, with irregular and jagged edges. They may only concern the external table or both tables. The occurrence of a pseudo extradural hematoma is ordinary but important to know whereas a subdural hematoma will have a perimortem meaning. It is important to know that toxins concentrations within these extradural hematomas seem to be particularly reflective of the perimortem toxins concentrations.

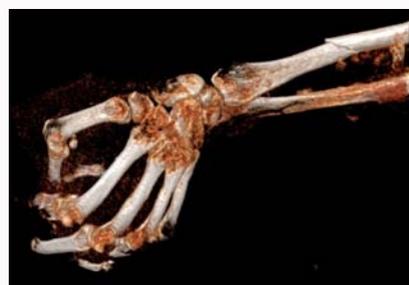
Figure 5: Radius oblique fracture, ulnar longitudinal fracture and overall amputation of the fingertips.

The overall analysis indicated a pugilist position and showed an oblique fracture of the distal third of the left radius in relation to a significant loss of subcutaneous substance and a left distal ulnar longitudinal fracture.

The patient also exhibited distal phalanges loss and numerous bilateral limb fractures involving metacarpals and phalanges of the upper limbs (Figure 5).

Thermal amputations are frequent in the presence of high temperature or a sustained heat source; they are due to disarticulations or thermal fractures. The upper limbs often appear in major retraction with thermal fractures of the hands and wrists (Figure 5). The thorax and abdominal-pelvic cavity appeared well preserved. Due to the anterior position of the teeth and their thinness, the incisors are the most exposed to alterations. According to Quatrehomme et al. [5], the enamel cracks as early as 150°C and fractures around 500°C, the unexposed dentine cracks around 600°C before disintegrating around 800°C [6].

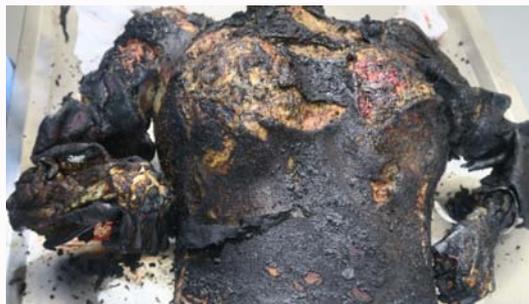
Figure 6: So-called pugilist position on upper limbs.

There was an almost diffuse state of carbonization of the body sparing part of the lumbar area and the posterior face of both thighs. In connection with the thermal phenomena, a retraction of upper limbs (the so-called pugilist position, cf Figure 6), an oblique fracture of the left radius also called "bec-de-flûte" (Figure 7) and of all the phalanges, extensive areas of skin tears involving the cephalic end, the anterior thoracic wall, upper limbs and both thighs were revealed.

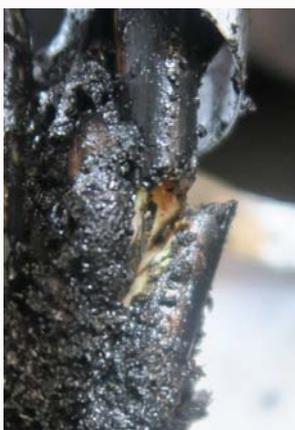
Figure 7: Oblique fracture also called "bec-de-fûte".

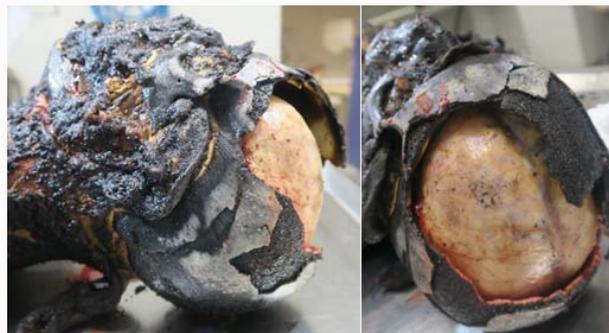
Figure 8: Burst skull associated with decortications areas of the external table and exposure of the dipole.

The autopsy performed on this corpse revealed a body with almost diffuse carbonization lesions with artifacts in link with thermal processes actions dominated by a burst skull (Figure 8), an oblique fracture of the left radius and numerous skin tears sites.

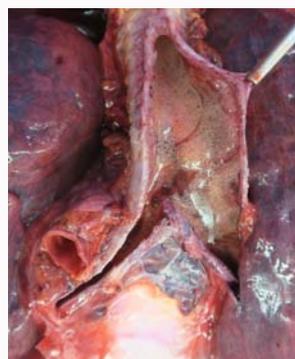
Figure 9: Black soot deposit and foamy secretions on pulmonary oedema in the trachea.

We also highlighted an asphyxia syndrome (diffuse visceral congestion, pulmonary edema, pleural petechiae) and a soot inhalation in the subglottic airways testifying to the breathing of the deceased in the fire fumes and reflecting the living status of the victim at the time of the fire (Figure 9).
